From: Barry Edwards [mailto:barry@intoss.co.uk]  
Sent: 19 November 2008 23:01  
To: Paul Harrison  
Subject: Fortoss Vital

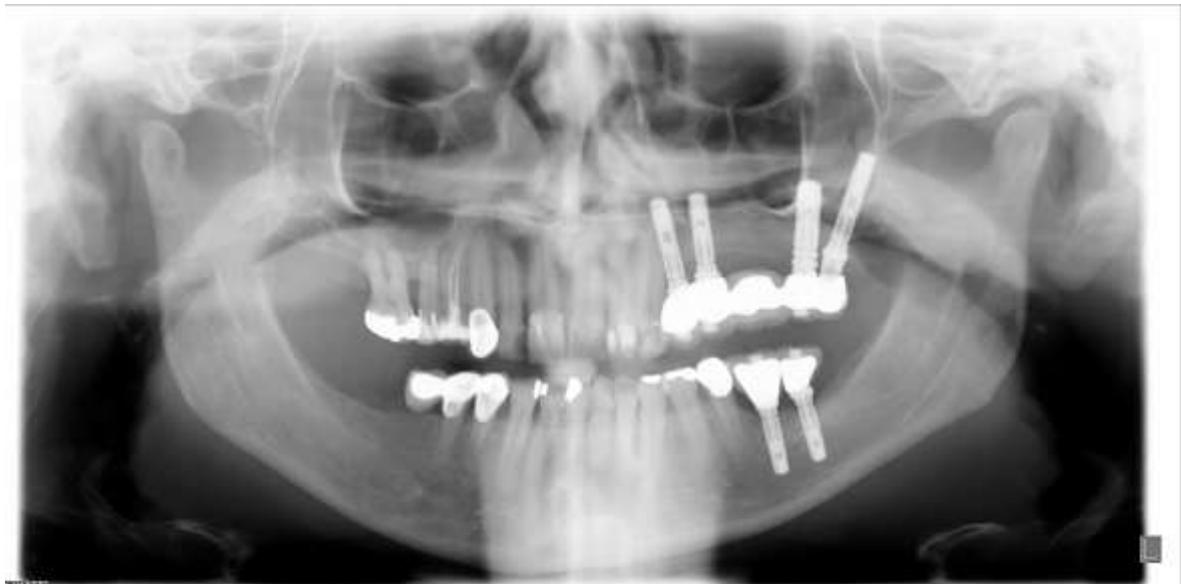
This is a radiograph of implants placed in the sinus at the same time as the Fortoss Vital graft. The sinus lining was perforated during the manipulation of the lining after the implants were placed and could not be repaired. Fortoss was syringed around the implants and allowed to set. The osteotomy window to the sinus was filled with more Fortoss and allowed to set. Healing was uneventful without oedema or pain.

The sinus lining appears to have regenerated over the graft resulting in rapid bone formation. This could be due to the mechanical rigidity and chemical similarity to healthy intact bone at the time of placement.
